## PROPERTY INSPECTION REPORT

**Prepared For:** Sample Report  
(Name of Client)

**Concerning:** 11736 Sample Report Rd  
(Address or Other Identification of Inspected Property)

**By:** Earl Stepp #8275 4/10/09  
(Name and License Number of Inspector) (Date)

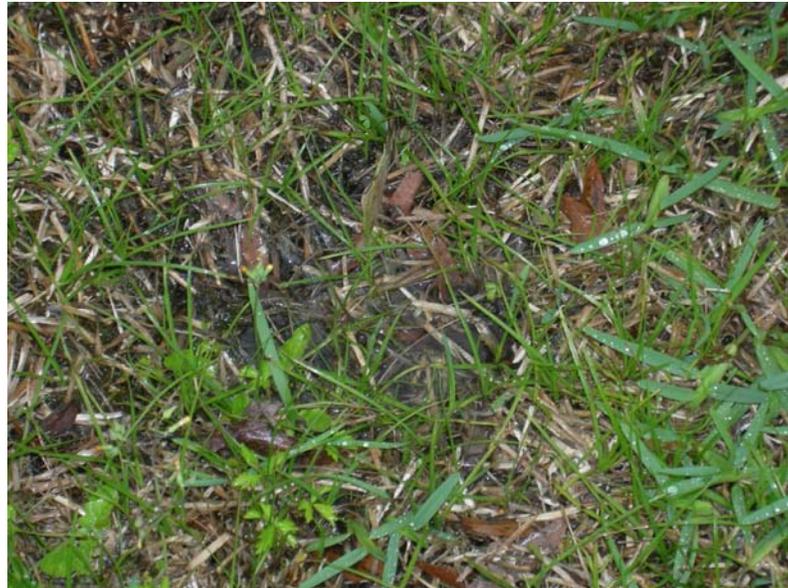
*Comments:* Ponding of water on the A/C side of House in the backyard.

*Guttering along the backside of the home would improve the drainage and direct rainwater off the house and away from the foundation.*

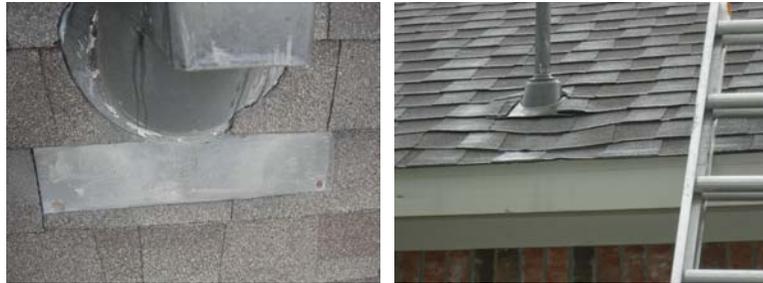
*Comments:* All exposed nails should be covered with roofing tar. All of the roof jacks on the roof have exposed nail holes that should be covered with roofing tar.

On the Air Condition side of the house (facing the house from the street-left side) there is roof decking deflection/sag. This is more than likely caused by the plumbing vent roof jack nails not being covered with tar, moisture getting in through nail hole then nail backing out, lifting roof jack up and rainwater getting into the area and

water damaging decking. A certified roofing company should be consulted to access the extent of damage and make necessary repairs to prevent further damage.

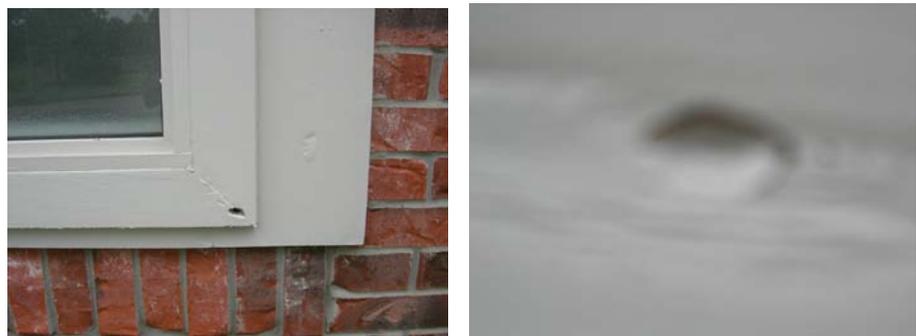
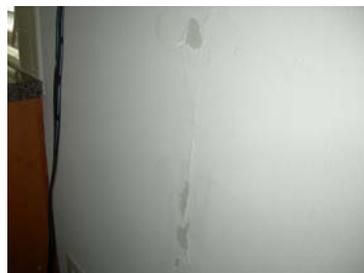
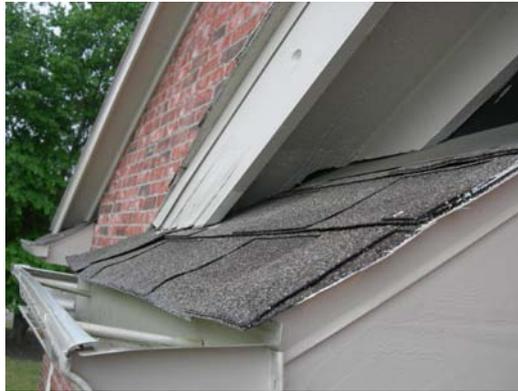
*Comments:* There are some rotted wood on some of the fascia boards, and trim around the windows and above front porch area. There is also some flaking of paint on the wall behind the refrigerator. The flaking appears to be in a straight line and is probably a poor quality of sheetrock being floated and taped.

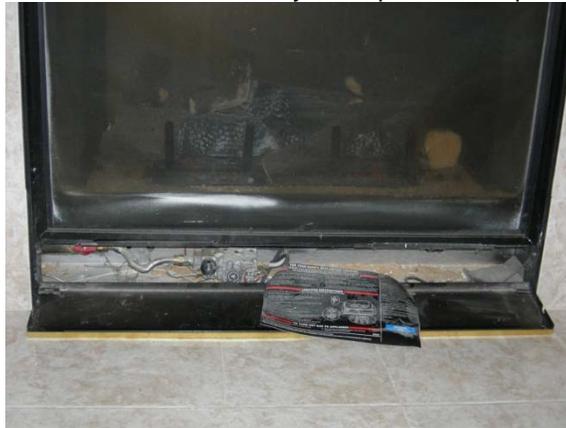
X                **J. Fireplace/Chimney**  
*Comments: I operated this unit for 15 minutes today with no issues.*  
 This fireplace is a heatilator . The system is draws air through the bottom vents, heat it up, and send it back into the room through the upper vent. The unit has a glass that is not removable.  
 There are instructions for use under the bottom baffle (gold) which folds down.

The fireplace is now working. Today, when testing I shot temperatures in the room. 74 degree air in the room and the hot air coming out the top baffle was around 120 degrees.

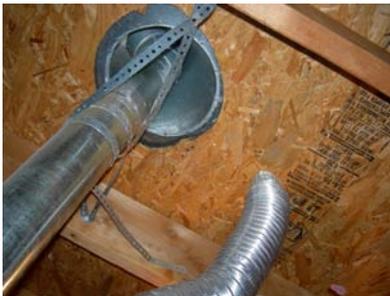
**G. Mechanical Exhaust Vents and Bathroom Heaters** - *Comments:* Exhaust vents for bathrooms should terminate outside so hot moist air is not discharged into the attic.

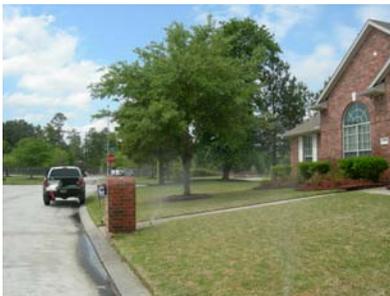
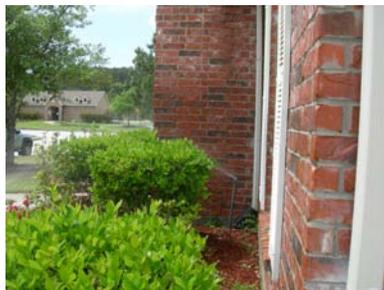
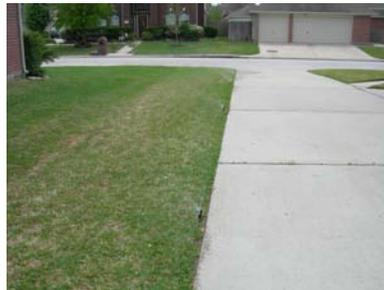
**A. Lawn and Garden Sprinkler Systems** - *Comments:* Operated Sprinkler System in test mode. All zones are operational.(Front Yard, Flower Beds, Side yard, and both areas of the back yard.) No issues.
